NASA TN D-6979

APOLLO COMMAND MODULE LAND-IMPACT TESTS

by J. E. McCullough and J. F. Lands, Jr.

Manned Spacecraft Center

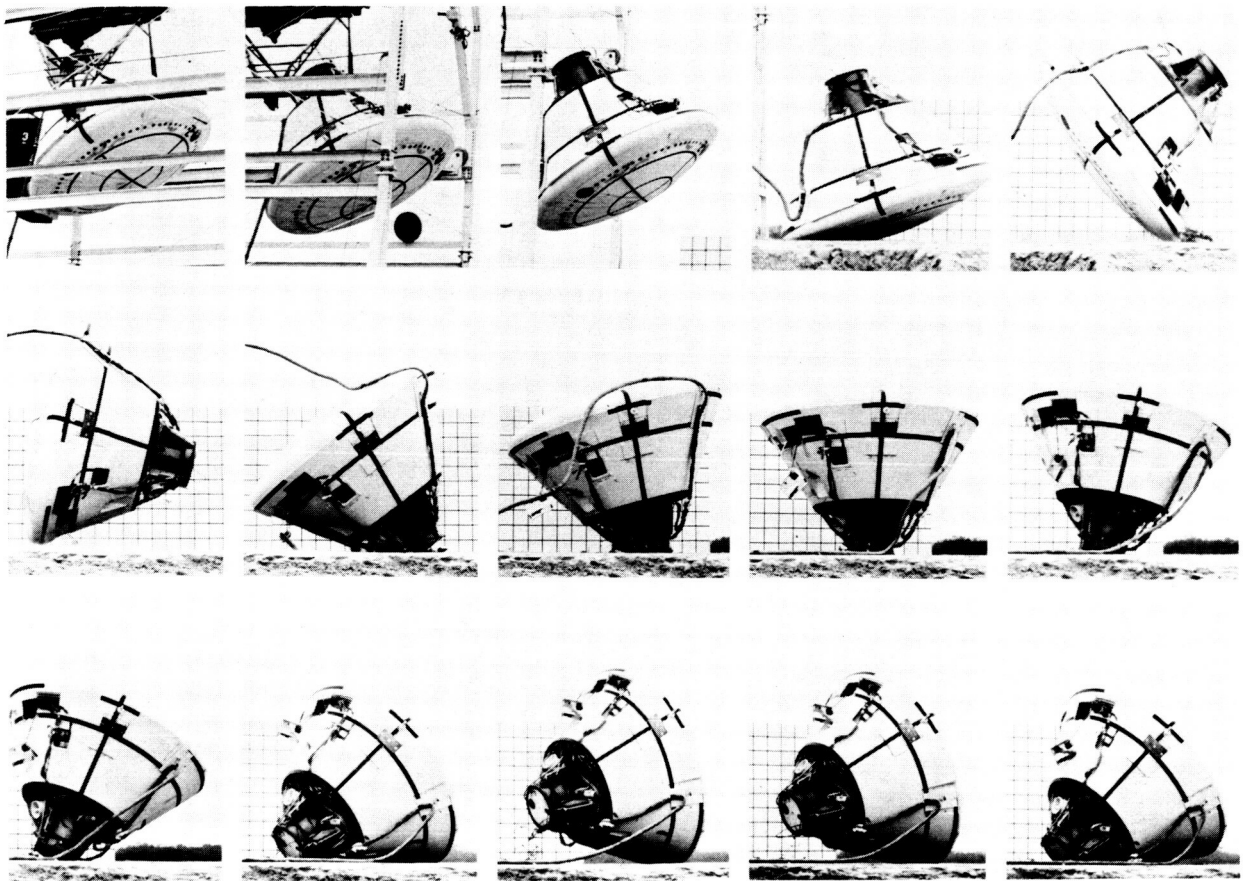
Figure 28. - Landing dynamics of CM-008 during test 28.

Conditions were selected for the test of CM-008 to assess the damage to the upper deck and docking tunnel should the second impact of a land landing occur on this area. The test conditions to achieve such an attitude at second impact included a roll of 180° , a pitch of -27.5° , and a horizontal velocity at initial impact of 25 fps. The kinematics of the test of CM-008 are shown in the photographic sequence of figure 28. The upper deck, the docking tunnel, and the +Z sidewall of the crew compartment were damaged extensively (fig. 29). Many fractures occurred in the structures of the docking tunnel and upper deck, and extensive debonding of the main-display-panel support occurred. However, all damaged members remained attached to the structure of the test vehicle and did not present a significant crew hazard. The aft bulkhead was buckled approximately 6 to 8 inches into the crew compartment by the aft heat shield, and the crew-compartment sidewall was cracked completely through its core on the +Z side. The initial impact conditions for test 63 (second test of CM-009) were selected to determine the effects of a secondary impact on the +Z sidewall.

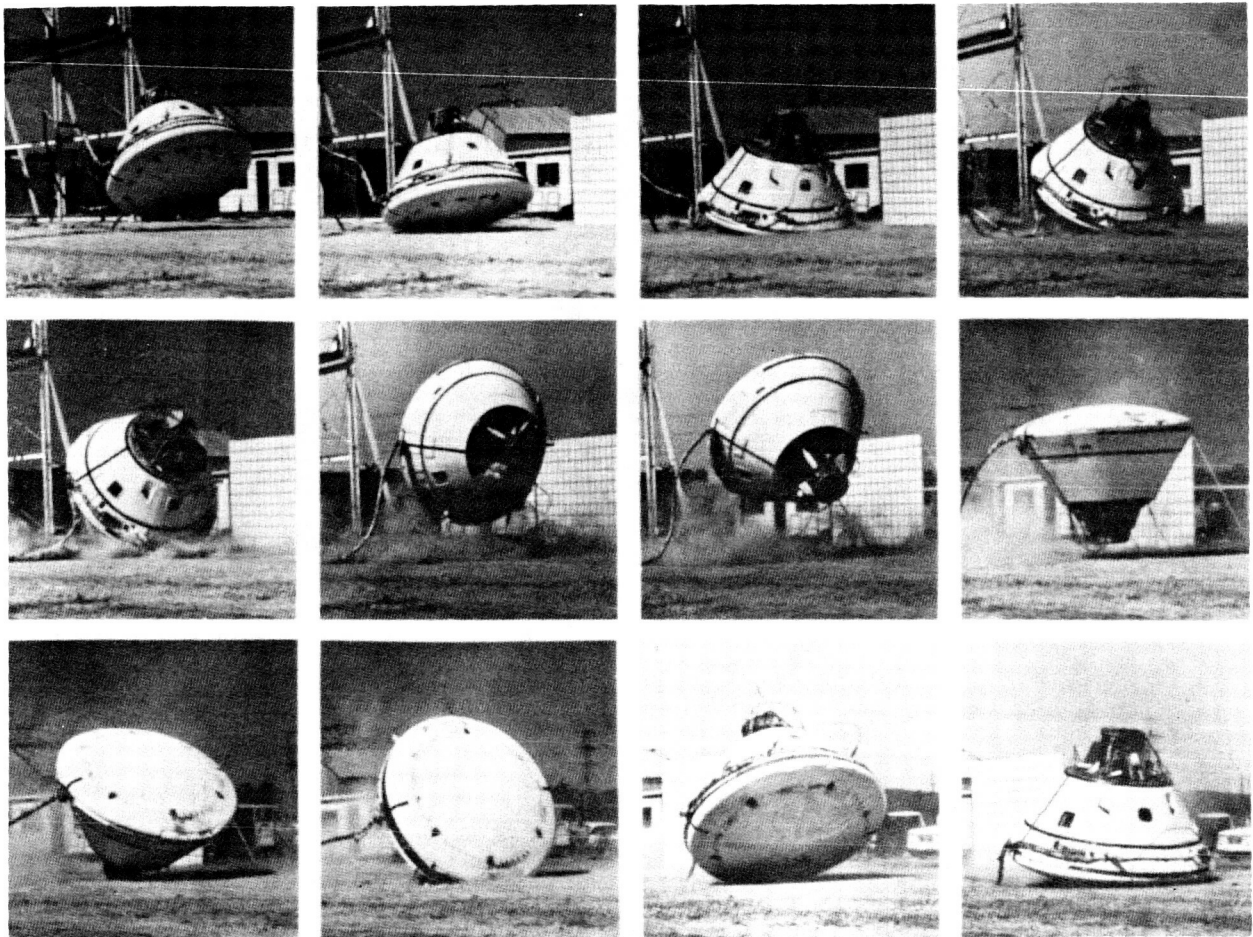
Figure 30. - Landing dynamics of CM-009 during test 63.

The impact test of CM-009 at 180° roll and 43.5 fps horizontal velocity produced more violent impacts than those of the CM-008 test. The rotation during the landing of CM-009 in test 63 is pictured in figure 30. The damage to the structure of the test vehicle in test 63 was more extensive than in any previous test. Damage to the docking tunnel and forward bulkhead was light, but significant damage occurred to the aft heat shield, aft bulkhead, and crew-compartment sidewall.

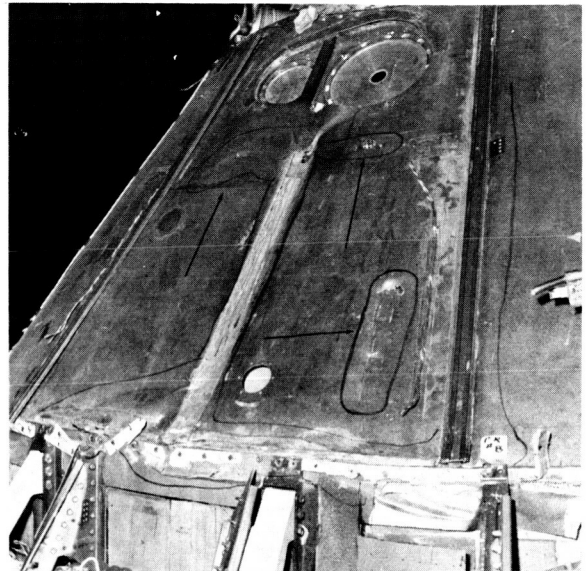
(b)

The crew-compartment sidewall between stations $X_c = 42.0$ and $X_c = 81.5$ on the +Z side was crushed inward by the crew-compartment heat shield (fig. 31(b)). Several large cracks occurred through the +Z sector of the sidewall behind the lower equipment bay (fig. 31(c)), and the entire lower equipment bay was debonded from the

sidewall, which caused the equipment shelves to deflect under their own weight approximately 2 inches. Although extensive damage occurred on the sidewall in the oxygen surge tank area (fig. 31(d)), the surge tank was not damaged.

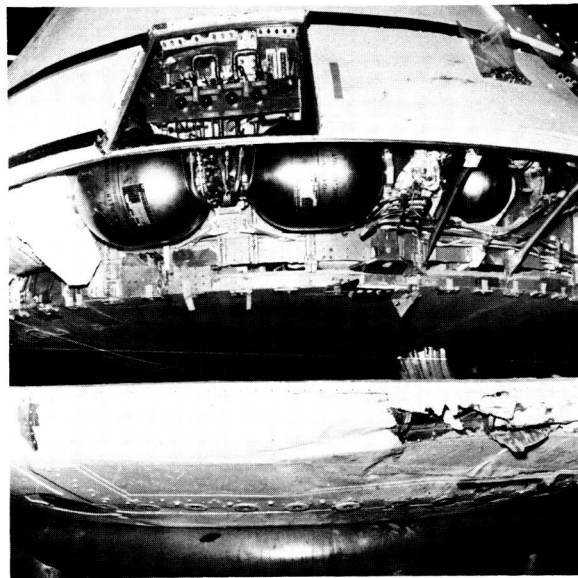
(f)

The aft-bulkhead core failed in shear in an area approximately 6 feet in diameter in the +Z sector, and a crack through both face sheets extended approximately 36 inches from the center in the +Z direction (fig. 31(e)). The oxidizer tanks were crushed, and the fluid from the tanks escaped and entered the crew compartment through the crack in the aft bulkhead. The aft bulkhead was separated from the crew-compartment sidewall through an included angle of 196° (fig. 31(f)).

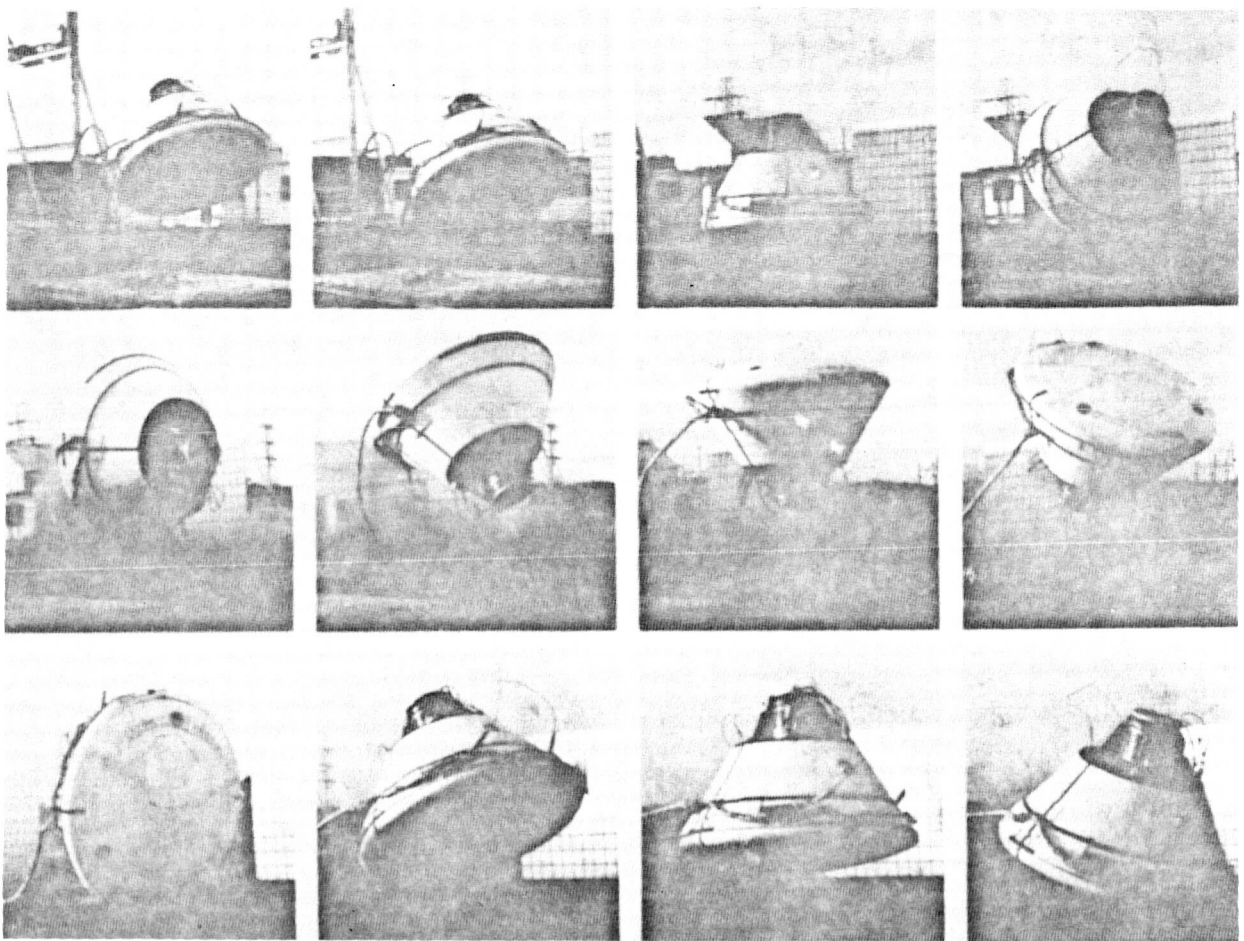
Figure 32. - Landing dynamics of CM-011 during test 64.

Test 64 with CM-011 was conducted at a horizontal velocity of 54 fps, equivalent to the maximum wind velocity in which the launch vehicle can be operated. The resulting kinematics were even more violent than those of test 63 with CM-009. The second impact of CM-011 occurred at a pitch attitude of approximately 300° and loaded the aft sidewall and heat shield more severely in the X axis direction and less in the Z axis direction than did the test conditions of CM-009. The aft area of CM-011 was damaged to a greater extent than that of CM-009. However, the separation of the aft bulkhead from the aft sidewall was less extensive, occurring throughout a 110° segment of the sidewall. The damage included numerous cracks in the aft bulkhead and sidewall that could permit the passage of toxic fumes and fluids from the aft equipment bay. On second impact, the sidewall beneath the crew hatch was crushed inward and upward from 12 to 18 inches, which fully compressed the Z-Z struts of the crew couch and produced high accelerations in the crew-couch system. The kinematics of the CM-011 test are shown in figure 32, and typical damage is pictured in figure 33.

Slight variations occurred in the impact kinematics between spacecraft tests 63 (CM-009) and 64 (CM-011) and similar tests of BP-1201. Essentially, the boilerplate vehicle was a rigid body. In contrast, the structure of the spacecraft yielded and absorbed a considerable amount of the impact energy. Furthermore, this deformation of the spacecraft changed the shape of the heat-shield surface about which the vehicle rotated before second impact.

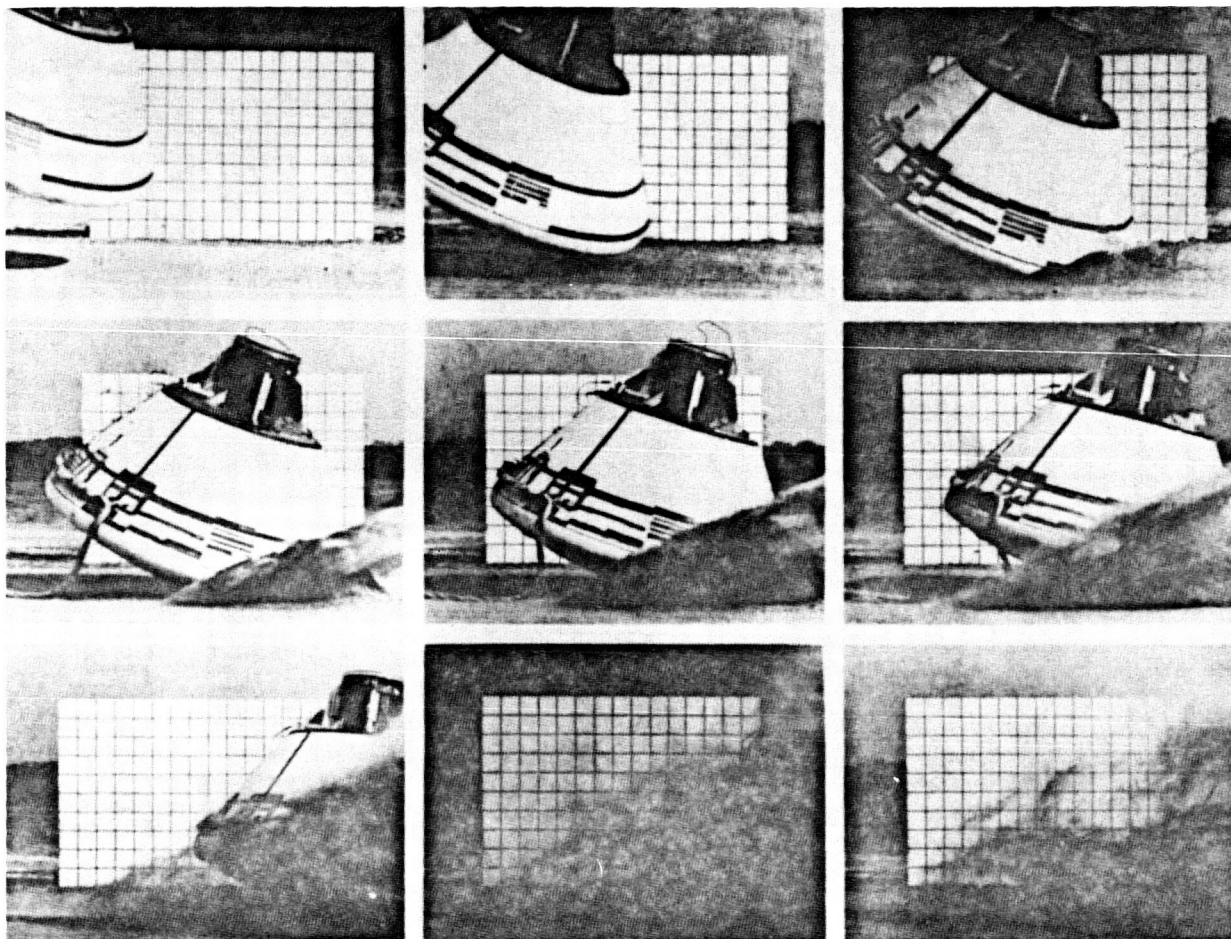
Figure 42. - Landing dynamics of CM-002B during test 68.

The CM-002B was impact tested at a roll angle of 325° and a horizontal velocity of 54 fps. The peak accelerations recorded at the c.g. were 30g in the X axis, 27g in the Y axis, and 11g in the Z axis. The shapes of the acceleration pulses were similar to those of the 0° roll tests and resembled a single pulse of approximately 0.045-second duration that has principal components of X and Z axis accelerations. The accelerations are shown in figure 40. The results of a boilerplate test under similar conditions are shown in figure 41. The CM-002B impact sequence is shown in figure 42.
